CARLO GAVAZZI SPACE SpA		AMS02-TCS		1 Doc.N°: NCR-TCS-CGS-C-006 N C R Rev.: 1 Date: 17.10.2008 ref Page 1 of 2 attach: 5	
		NON CONFORMANCE REPORT

2 NCR Title: HEATERS DE-BONDING					
---------------------------------	--	--	--	--	--

RAM RADIATOR Heaters

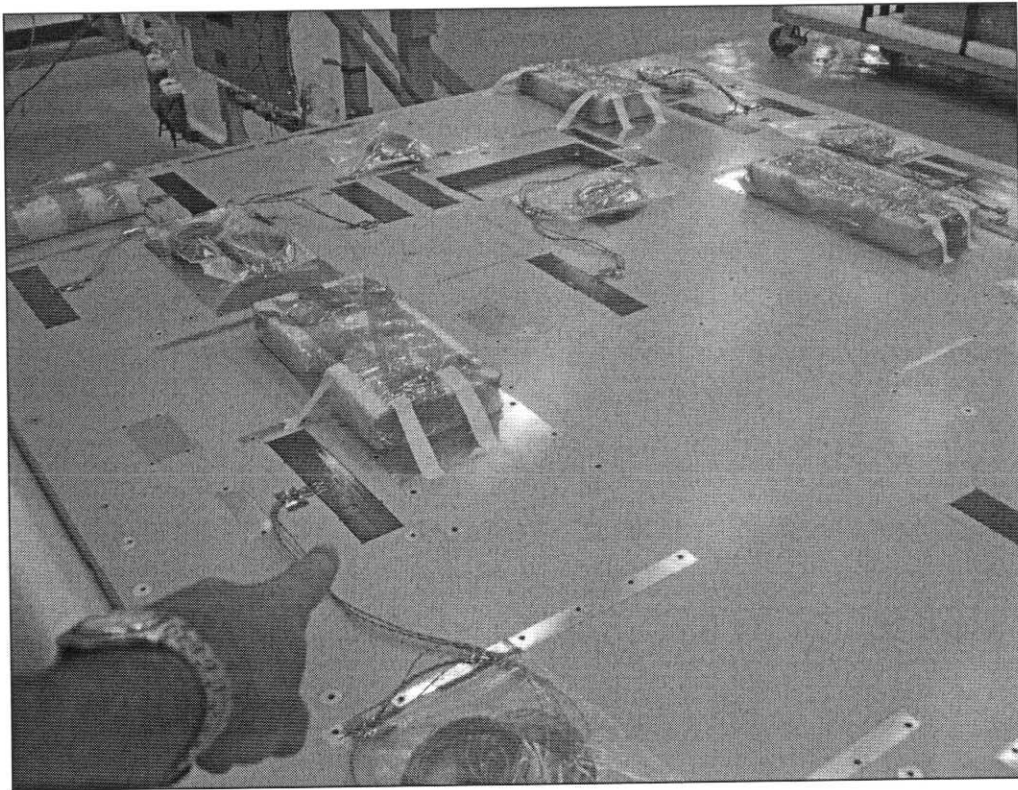
Heater#8-3

Defect type : straight long bubble

The chofoil application guidelines have been reported in the annexed Minute of meeting (AMSTCS-MI-CGS-034 , annex 4 to this NCR) and here summarized .
Owing to the air bubble risk the step 2 has been modified according to the documentation shown in annex 5:

- 1- Check bubble size and if the diameter is less 15mm proceed with the chofoil application
- 2- Around the glue drops of the heater patch perform the activity shown in Annex 5
- 3- Clean the heater surface with IPA
- 4- Cut stripes of chofoil tape (CCJ-36-201-0100) and apply the stripes over the heater extending the tape out off the heater edge nearly 10mm.
- 5- Make the tape stripes overlapping each other by 5mm
- 6- Let the tape perfectly adhere the heater/overlapped tape with a pressure of a teflon tool
- 7- Adjust the chofoil all around the lead exit avoiding to cover the cables
- 8- Secure the chofoil tape all around the heater with drops of glue (EC2216 B/A Gray)
- 9- Take pictures of the reworked activities

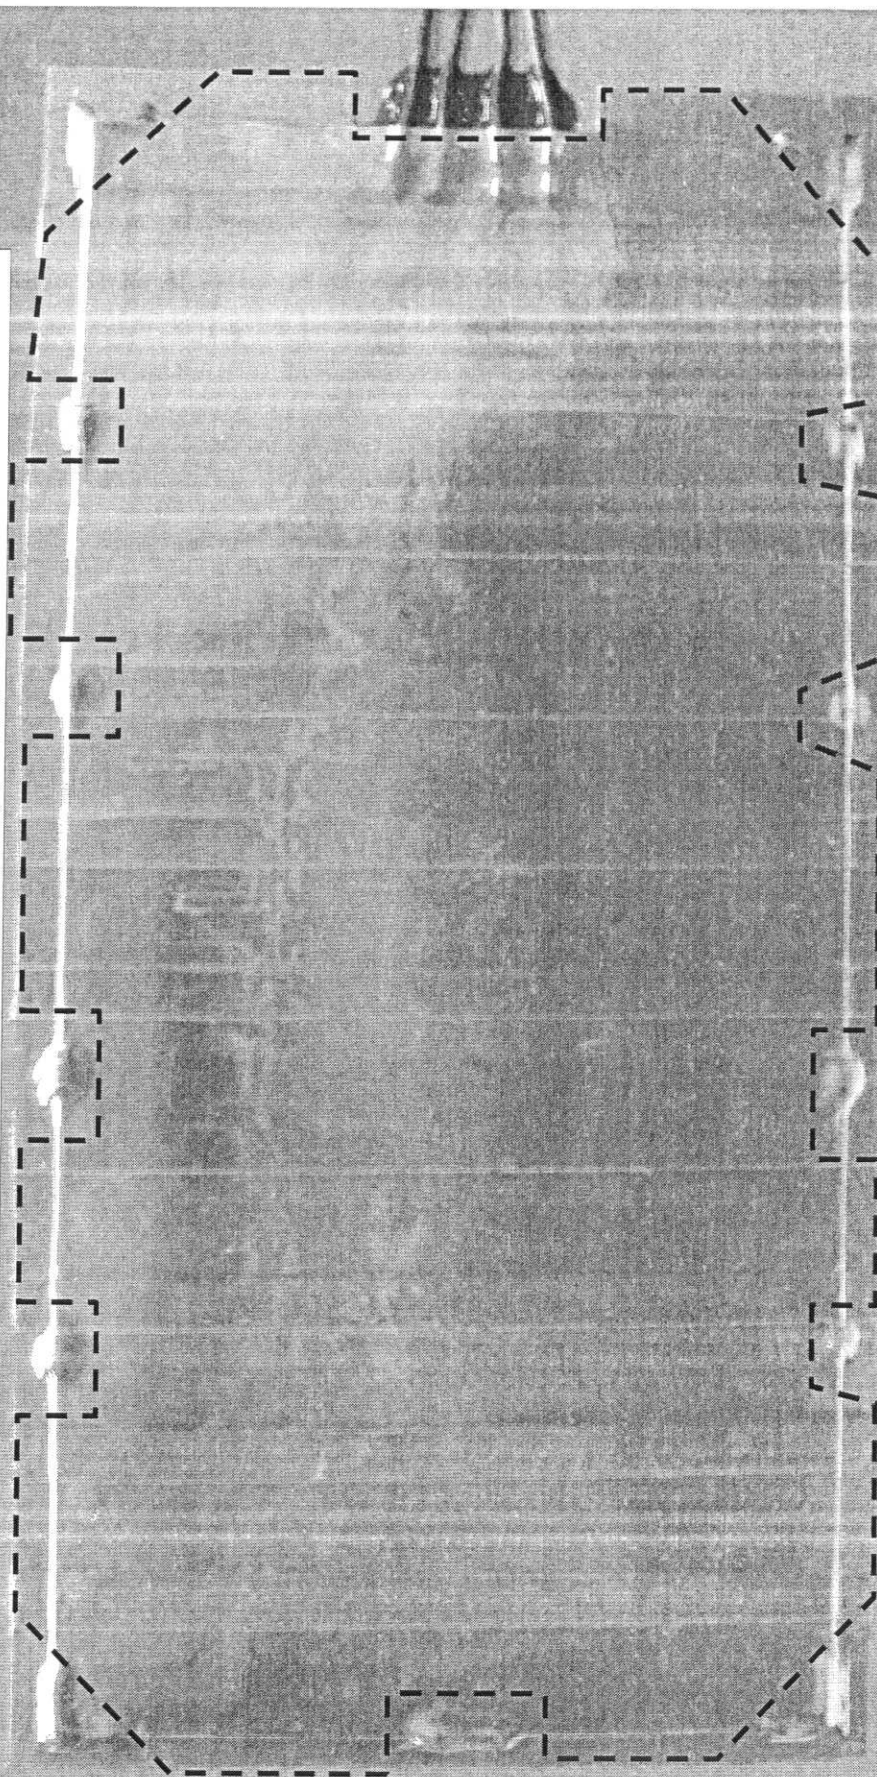
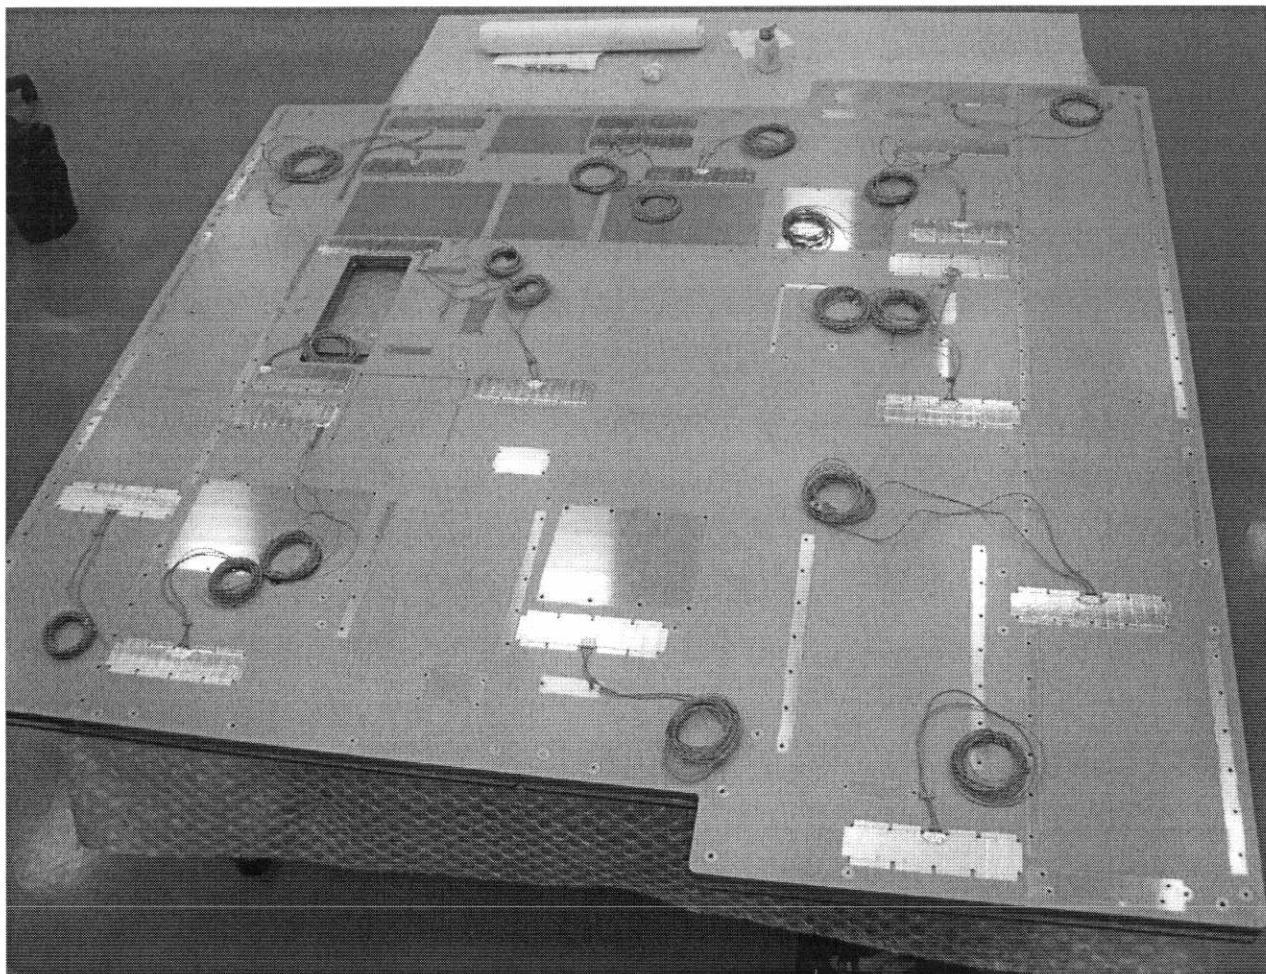
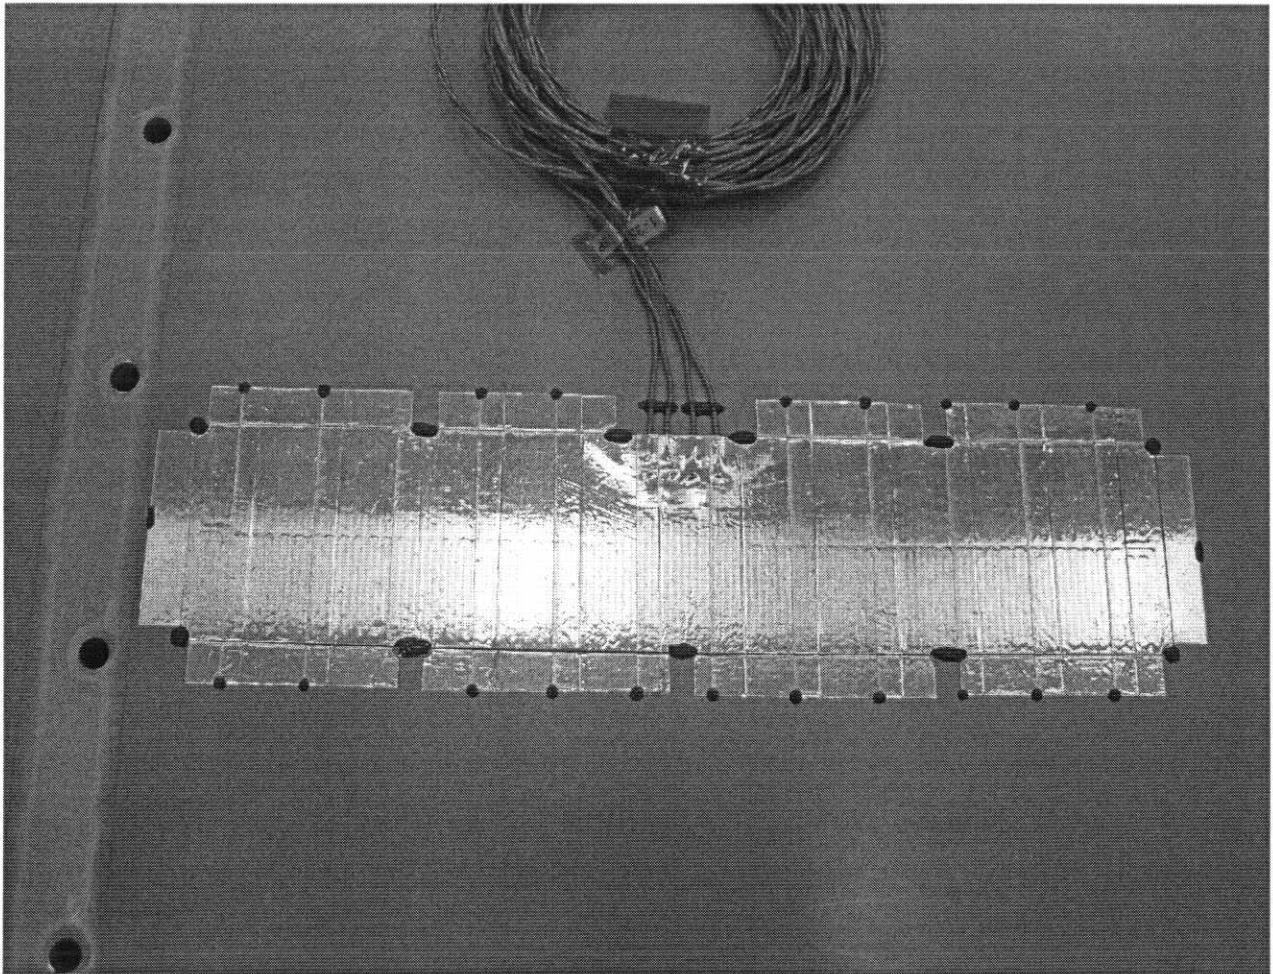
TIME CONSUMING BUT NO AIR BUBBLES RISK

PREFERRED SOLUTION

(TAPE SHAPED BEFORE INSTALLATION ON HEATER)

We therefore advise to use the tape removing a small portion of it all around the glue spots, shaping the tape before application to the heater as showed on the last annexed slide.
This approach is time consuming but safe.
